*NIST Special Publication 862*

# 1994 Northridge Earthquake

## Performance of Structures, Lifelines, and Fire Protection Systems

*Diana Todd, Nicholas Carino, Riley M. Chung, H. S. Lew, Andrew W. Taylor,  
William D. Walton, James D. Cooper, and Roland Nimis*

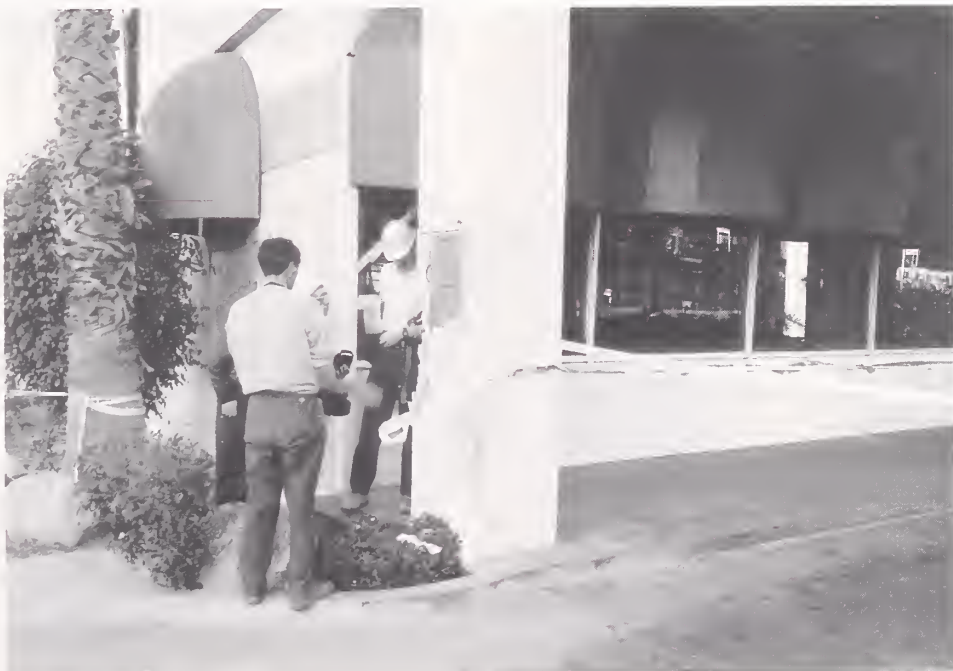
Figure 3.56. The columns supporting the three-story appendage at the front of the Radisson Hotel had serious shear cracks and related spalling.

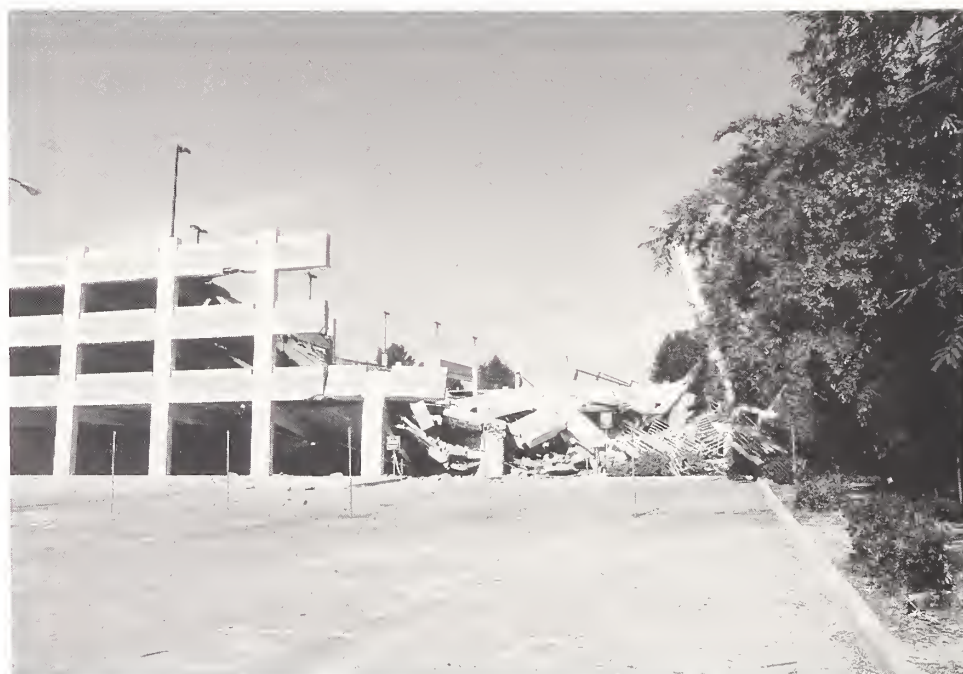
The collapse apparently started at the interior of the building. The exterior perimeter frame was pulled over towards the center of the structure (fig. 3.60), suggesting that interior beams had lost their vertical support, causing the floor plates to collapse and pull the exterior walls in with them. While some interior columns had collapsed, others were left intact, jutting up above the fallen floor slabs (fig. 3.61).

Figure 3.61. Some interior columns of the Northridge campus parking garage remained standing.

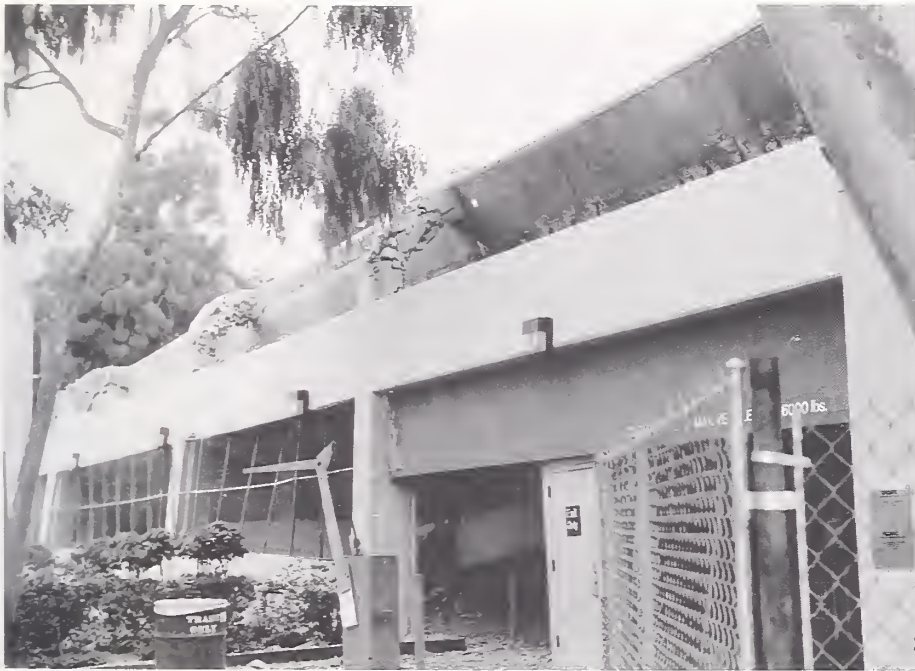
The five-level parking garage at the Kaiser Permanente medical complex on Cadillac Avenue in West Los Angeles experienced a similar collapse. All four facades were pulled inward, suggesting that an interior failure precipitated the damage (fig. 3.62). This garage was a post-tensioned cast-in-place concrete structure with shear walls providing the lateral-force resisting system at the east and west ends, and moment frames at the north and south perimeter. The shear walls were cracked horizontally throughout their height due to the out-of-plane bending (fig. 3.63). There was minor diagonal cracking, suggesting that the lateral load was not fully transmitted to the shear walls. The stair towers remained standing. Typically, these towers are structurally isolated from the post-tensioned slab to minimize potential deformations in the towers due to creep and shrinkage in the post-tensioned slabs.

Figure 3.62. The cast-in-place concrete parking garage at the Kaiser Permanente Hospital complex in West Los Angeles collapsed in on itself. The moment frame that provided lateral resistance on the south face of the structure could not resist the out-of-plane forces apparently caused by the collapse of interior elements.

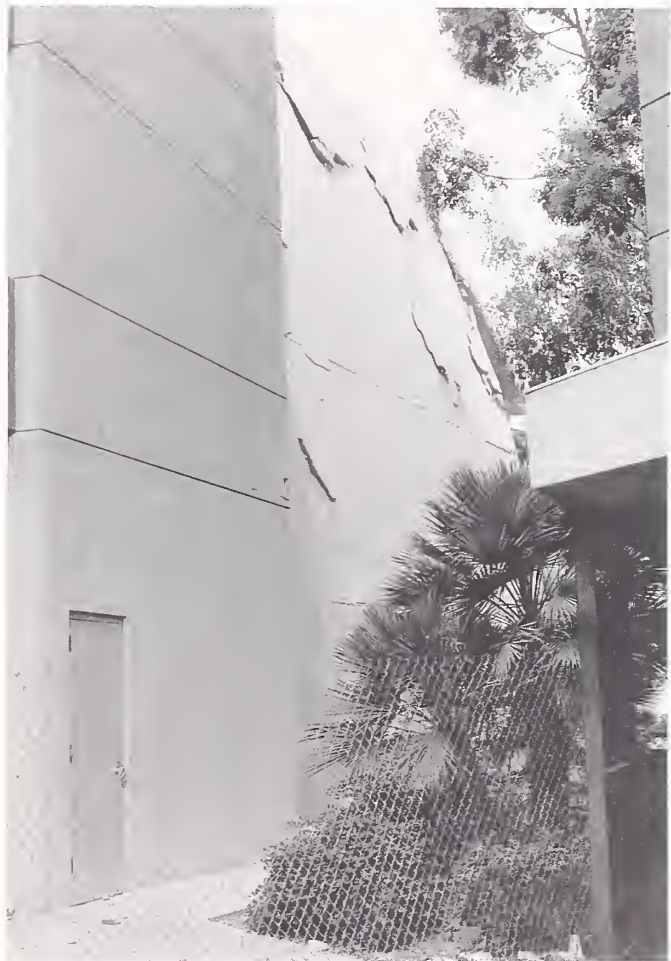
Figure 3.63. At the east and west faces of the Kaiser Permanente Hospital parking garage, shear walls made up the lateral force resisting system. Both walls had horizontal cracks caused by the out-of-plane bending when the walls were pulled inward. Neither wall had major diagonal cracking, suggesting that the lateral load was never fully delivered to the walls. The stair towers remained erect. The east wall and stair tower are shown here.

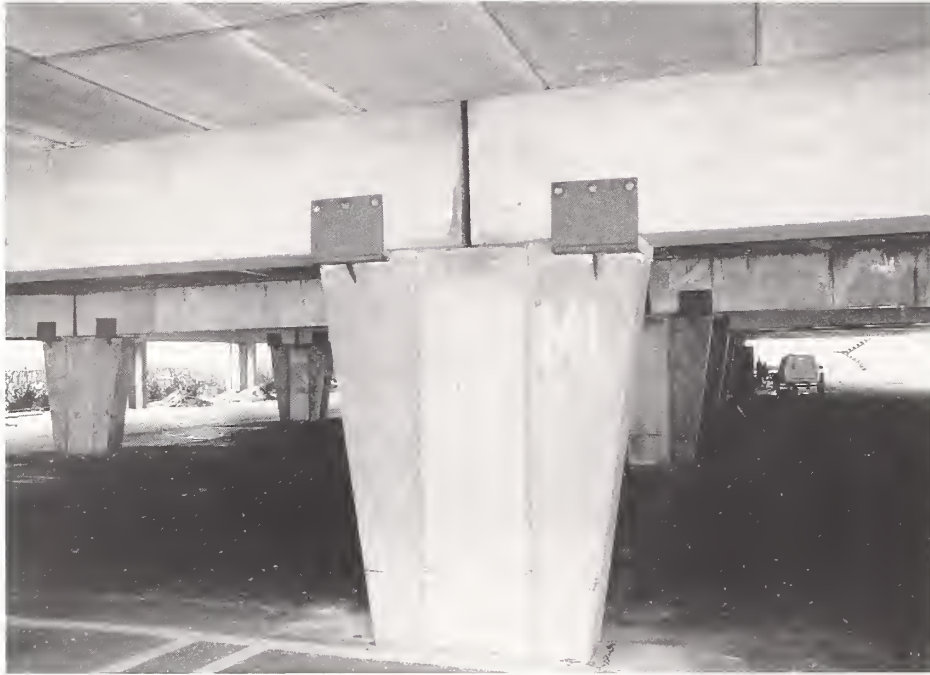
The two-level concrete parking structure adjacent to the Trans World Bank in Sherman Oaks had been seismically strengthened after suffering serious damage in the 1971 San Fernando quake. Flared extensions were cast next to the interior columns along their north-south axes (fig. 3.64), creating short wing walls supporting the precast beams. During the 1994 quake, the unrehabilitated exterior columns were badly cracked (fig. 3.65). The ramp was also heavily damaged. The interior columns were relatively undamaged.

Figure 3.64. The interior columns of the two-level parking garage at the Trans World Bank in Sherman Oaks had been seismically strengthened after it suffered damage in the 1971 San Fernando quake. The interior columns fared well in the 1994 Northridge quake.

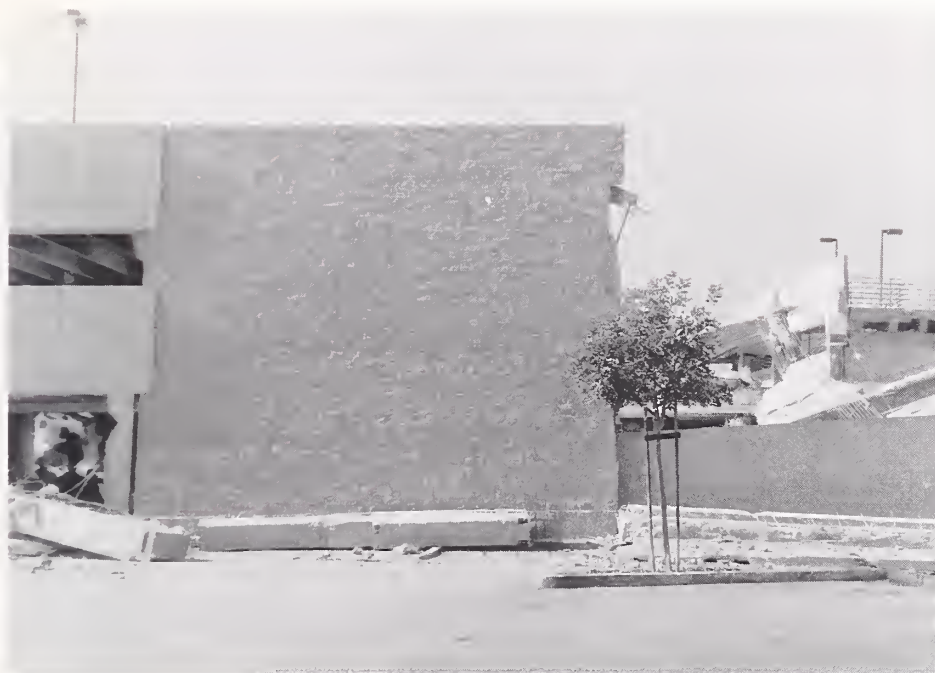
At the Northridge Fashion Center, three parking structures suffered damage. A large three-level concrete garage at the south end of the site, approximately 10 years old, suffered an almost complete collapse. The largely pre-cast concrete structure had intermittent shear walls which remained standing (fig. 3.66). The lack of diagonal cracks in these walls suggests that, like the walls at the Kaiser Permanente garage, they were never fully loaded. A similar, but smaller, precast garage at the north end of the Northridge Fashion Center also partially collapsed (fig. 3.68). At the east end of the site, an older two-level cast-in-place concrete garage showed

Figure 3.66. At the Northridge Fashion Center, major portions of the three-level south parking garage collapsed. The garage was precast concrete with intermittent shear walls. Most of the shear walls remained standing, largely undamaged, indicating that the lateral load was not adequately transmitted to these walls.

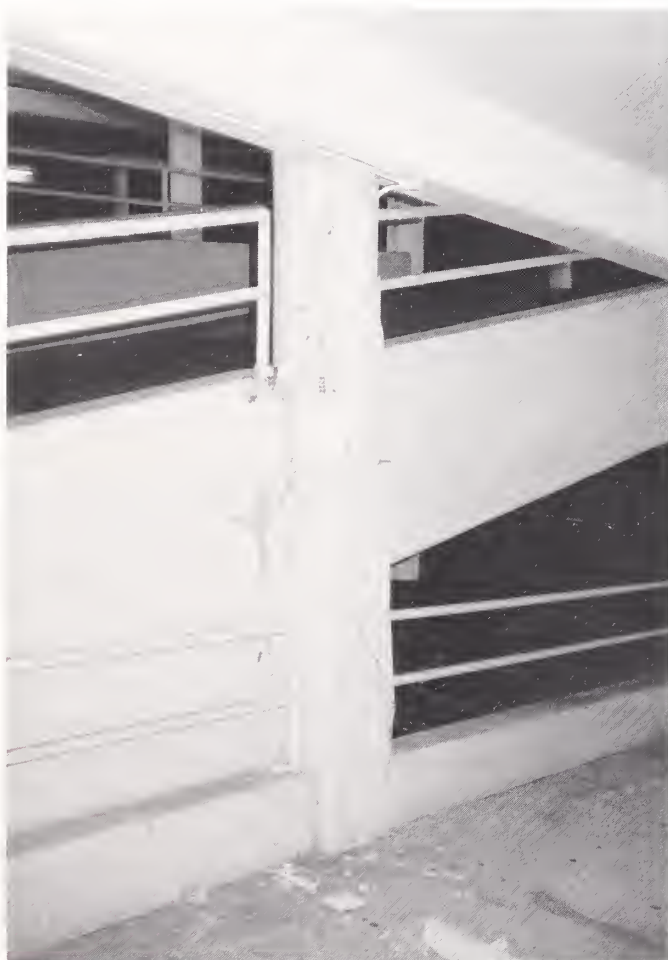
Common types of damage in other parking garages included shear-failure in unintentional short columns created by ramps or split-level decks (fig. 3.67) and collapsed decks caused by inverted-T's or concrete planks pulling off supports (fig. 3.68).

Figure 3.67. In parking garages, ramps can cause unintentionally shortened columns, which are vulnerable to damage, as shown here.

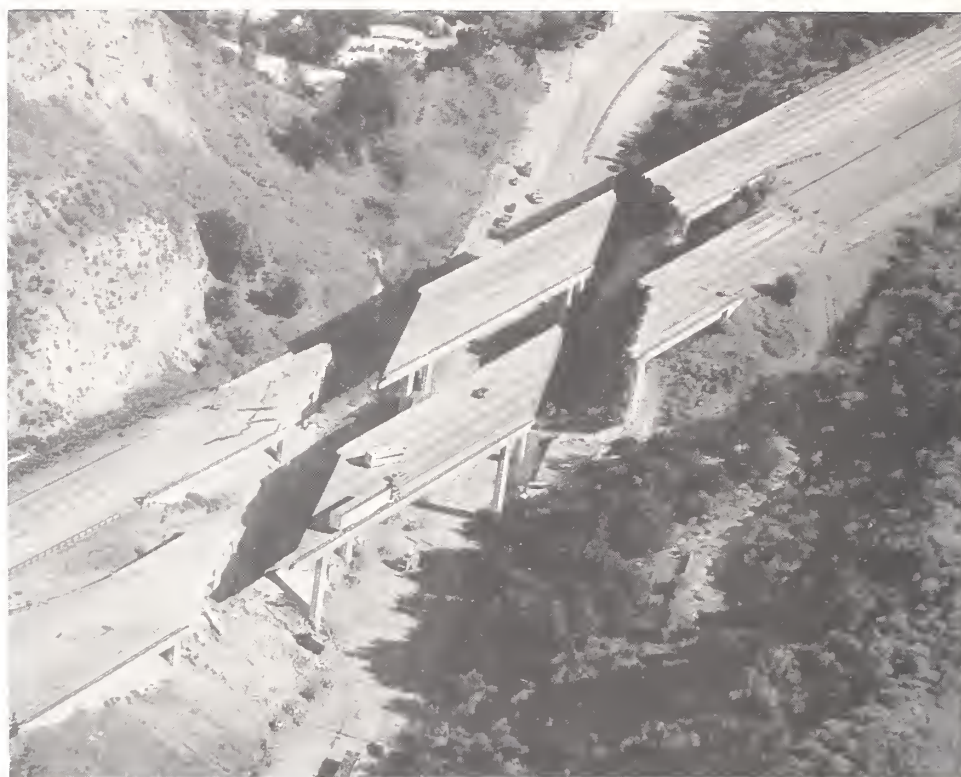
Despite the presence of cable restrainers at the hinges, failure of three of the four end spans of the bridge was apparently initiated by the spans falling off the hinge seats. The fourth end span, at the far western corner of the bridge, partially came off its hinge seat but did not collapse, as indicated in figure 4.4. After support was lost at the hinges, a triangular portion of three of the end spans collapsed, as shown in figure 4.4. Demolition of the remaining portions of the end spans was carried out very soon after the earthquake, as shown in figure 4.2. It is likely that the skewed alignment of the bridge was an important contributing factor in this failure. The skewed alignment permitted rotation of the superstructure in a counter-clockwise direction, when viewed from above. The tall, flexible piers of the two center bents would have offered relatively little resistance to rotation in a horizontal plane. (EERC reconnaissance team members noted cracking patterns at the bases of the piers, which may have been evidence of such rotation [5]). Rotation of the superstructure would have resulted in differential displacements at the hinges, and eventually unseating of the end spans at the hinges. Demolition of the bridge was completed a few days after the earthquake.

Figure 4.2. Aerial view of the bridges at Gavin Canyon, looking to the east, showing appearance of the four end spans shortly after demolition had begun.

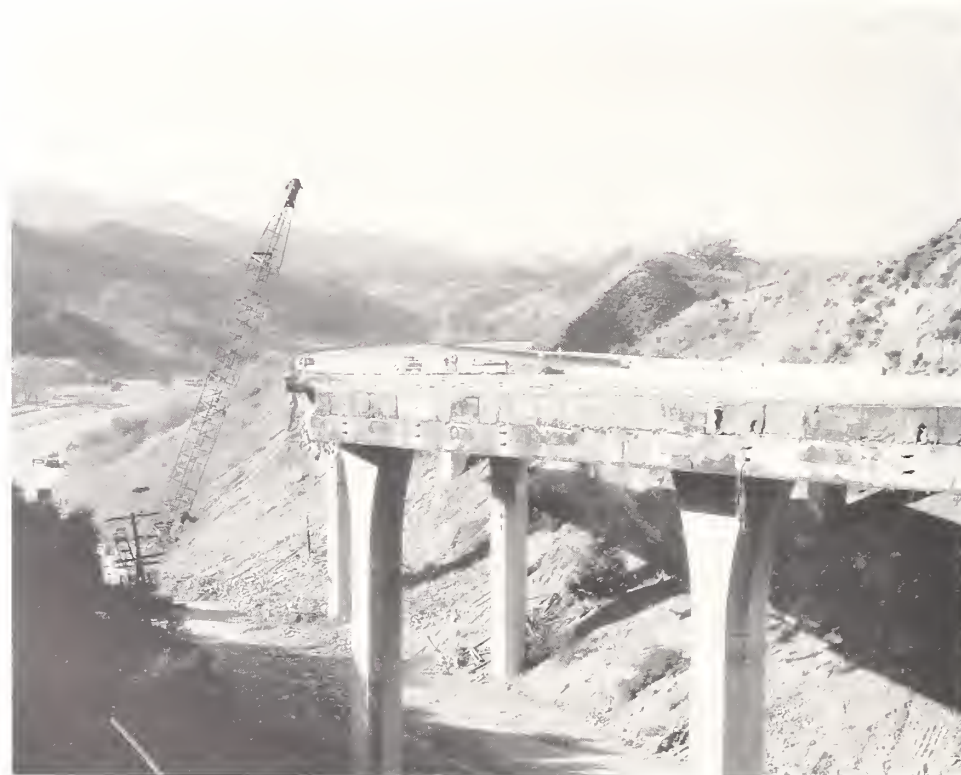
Figure 4.3. Ground level view of the southbound bridge at Gavin Canyon, looking to the northwest, showing the hinge bearing seat near Bent 3.

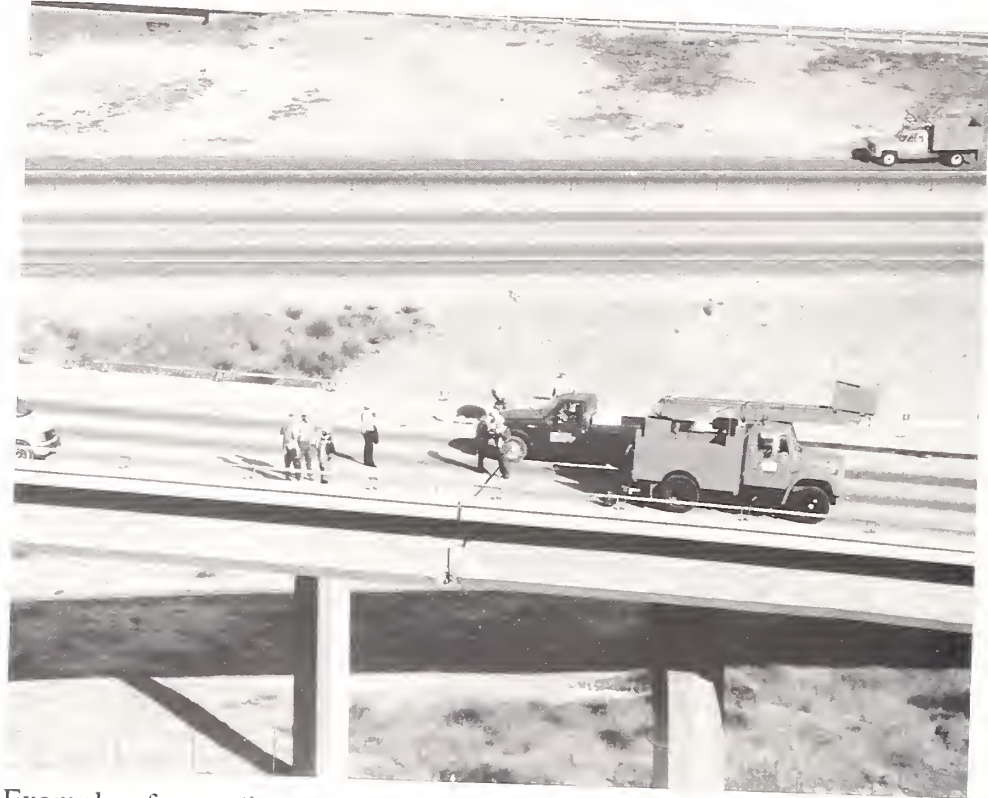
Figure 4.7. Example of pounding and offset at a hinge in the SR14/I5 interchange.

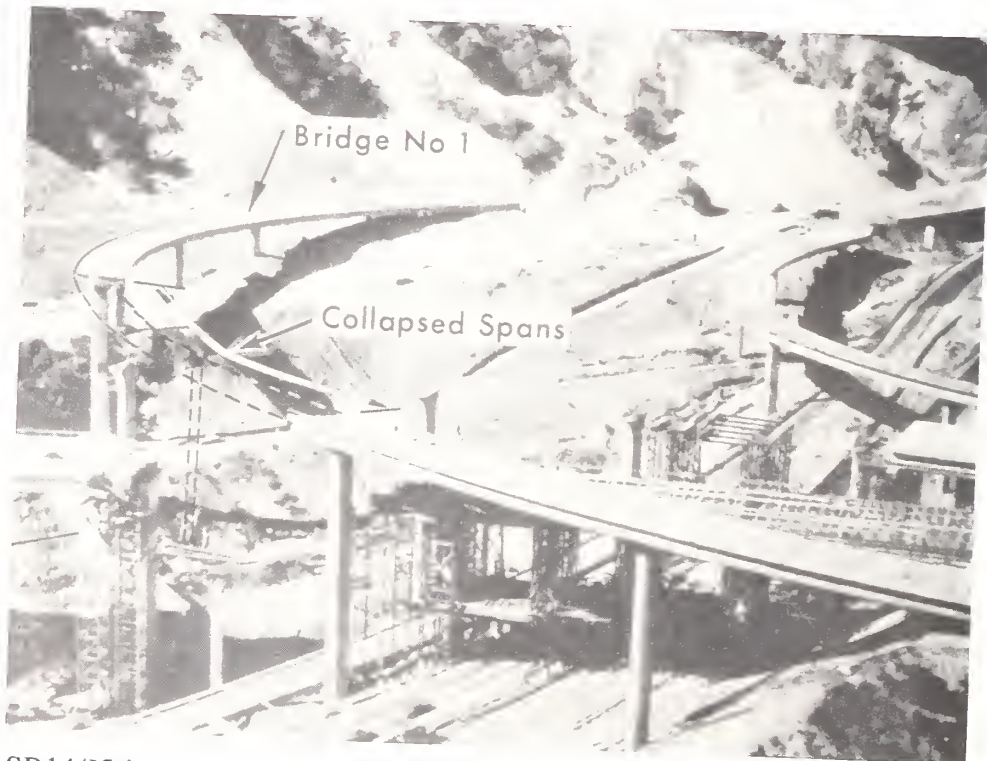
Figure 4.8. SR14/I5 interchange after the 1971 San Fernando earthquake. View looking to the west, showing collapsed South Connector Overcrossing.

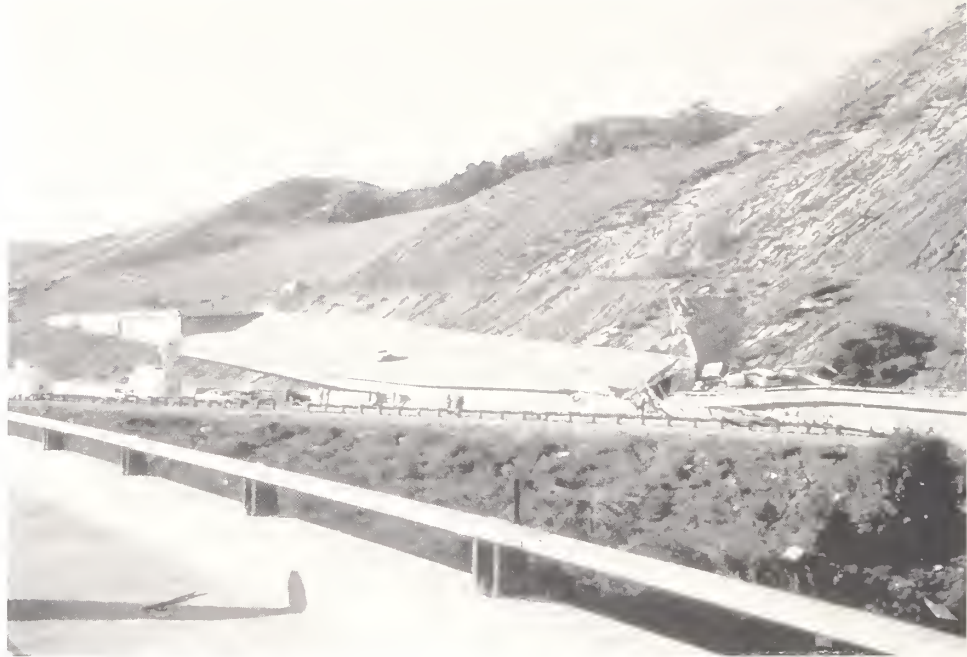
Figure 4.11. Overview of the collapse of the SR14/I5 Separation and Overhead, Ramp C, looking to the south at Abutment 1. Pier 3 can be seen at the right of the photograph (Photo courtesy of EERC).

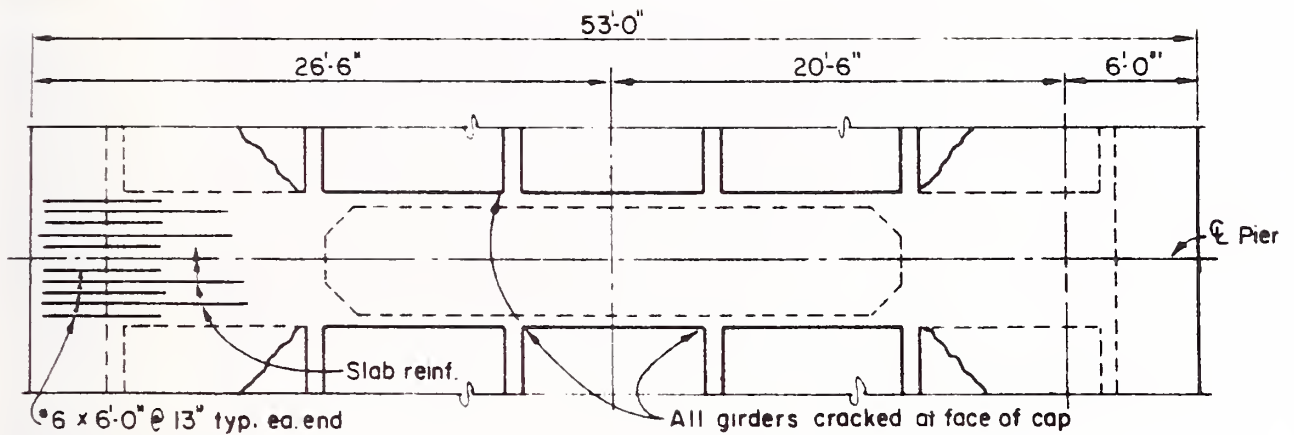
Figure 4.13. Cracking reported at Piers 2 and 3 following the 1971 San Fernando earthquake (reproduced from "The San Fernando Earthquake: Field Investigation of Bridge Damage," State of California, 1971).

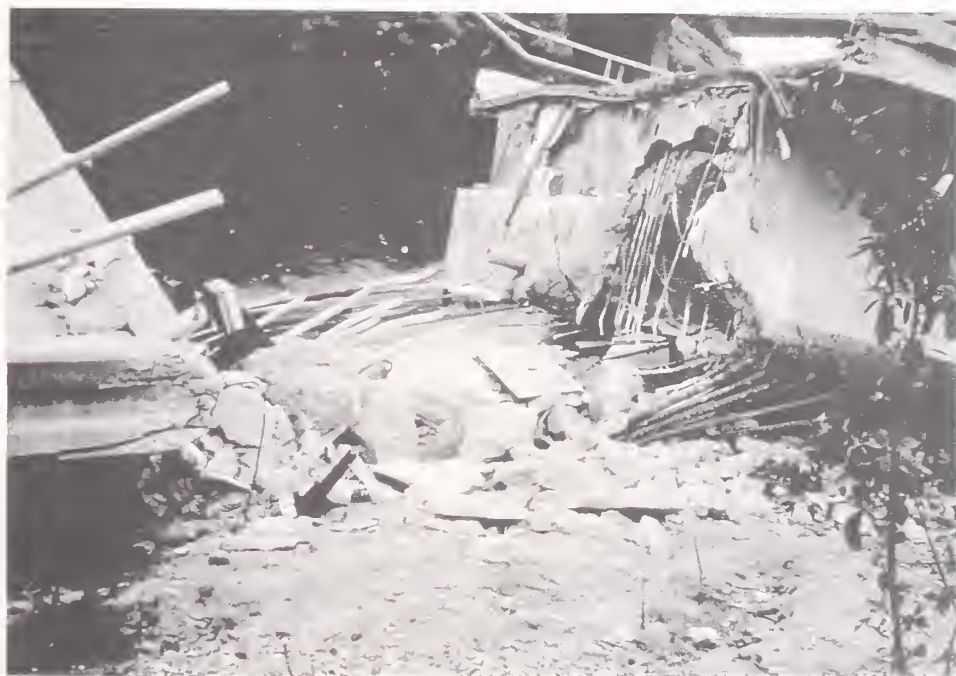
The collapse in the Northridge earthquake appears to have been initiated by the failure of Pier 2. After Pier 2 failed, the simply supported span between Abutment 1 and the hinge near Pier 2 collapsed, and, as shown in figure 4.15, the superstructure failed near Pier 3 due to a large negative moment. Pier 2 completely disintegrated, as shown in figure 4.16. This is the shortest pier in the structure, so it is likely that it attracted a high level of lateral force, was damaged in shear, and finally collapsed in compression. Pier 10 is similar in height to Pier 1, but the quantities of lateral reinforcement in Pier 10 are greater than those in Pier 1, as shown in figure 4.18. This is because Pier 2 had already been completed, but Pier 10 had not yet been constructed, when the 1971 earthquake occurred. Following the 1971 earthquake the plans for Pier 10 were revised to provide increased lateral reinforcement, as shown in figure 4.18.

Figure 4.16. View of crushed Pier 2 and the hinge near Pier 2 (Photo courtesy EERC).

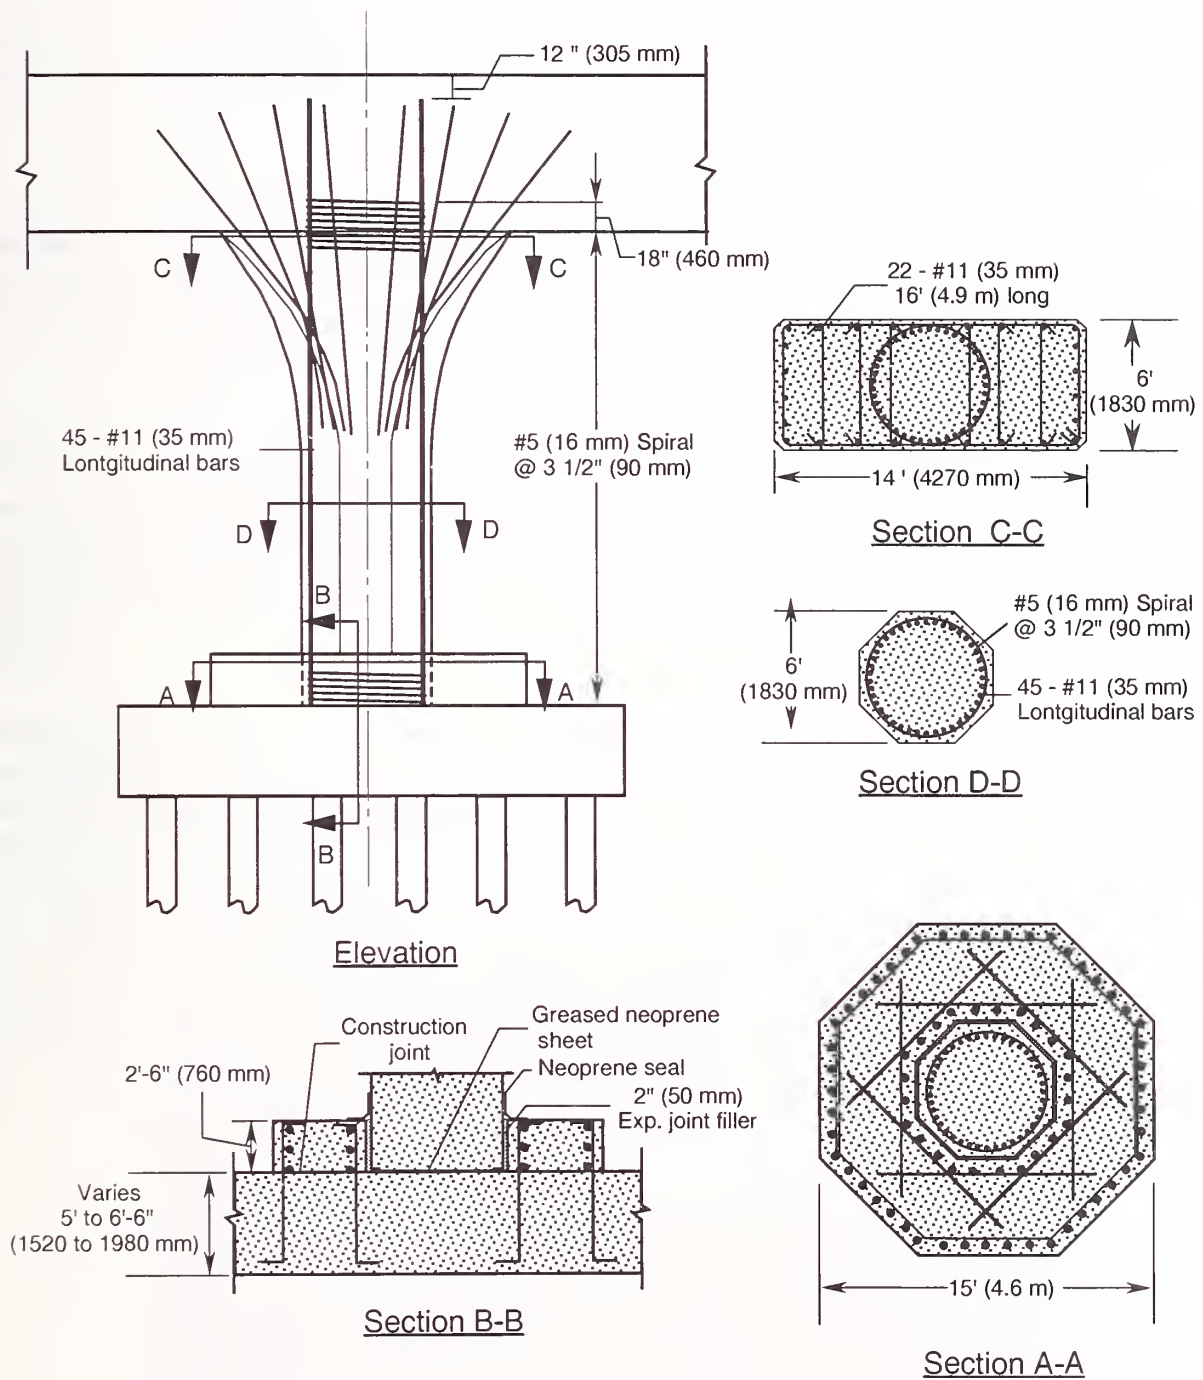
# SR 118 - Mission-Gothic Undercrossing Pier Details

The second, and perhaps more important, feature of this bridge is the geometry of the bridge piers. Pier details are shown in figure 4.24. The piers were all relatively short, roughly 7200 mm (24 ft) tall by 1800 mm (6 ft) across, making an aspect ratio of only 4:1. However the piers also featured architectural flares at the tops, roughly 3600 mm (12 ft) tall. These flares were intended to be non-structural features of the piers. It was believed that the flares would spall or otherwise deteriorate during earthquake loading so that they would not contribute to the bending stiffness of the piers. However, it is clear that in actual performance the flares created a zone of added stiffness, reducing the aspect ratio of the piers to approximately 3:1. Thus the piers were very stiff laterally, and were dominated by shear rather than bending. The detail at the footing/pier interface was also somewhat unusual for this bridge. Figure 4.24, section B-B, shows that the base of the pier rested inside a collar at the top of the pier footing. This detail was intended to permit free translation of the pier base during post-tensioning operations of the superstructure, before the collar was cast. The detail also had the effect of creating a hinge at the pier base. It is not immediately apparent whether this hinge improved or worsened the seismic performance of the bridge, although for a given lateral force the bending moments at the tops of the piers were greater than if the hinges at the bases of the piers had not been present.

Figure 4.24. Pier details for the SR118 Mission-Gothic Undercrossing.

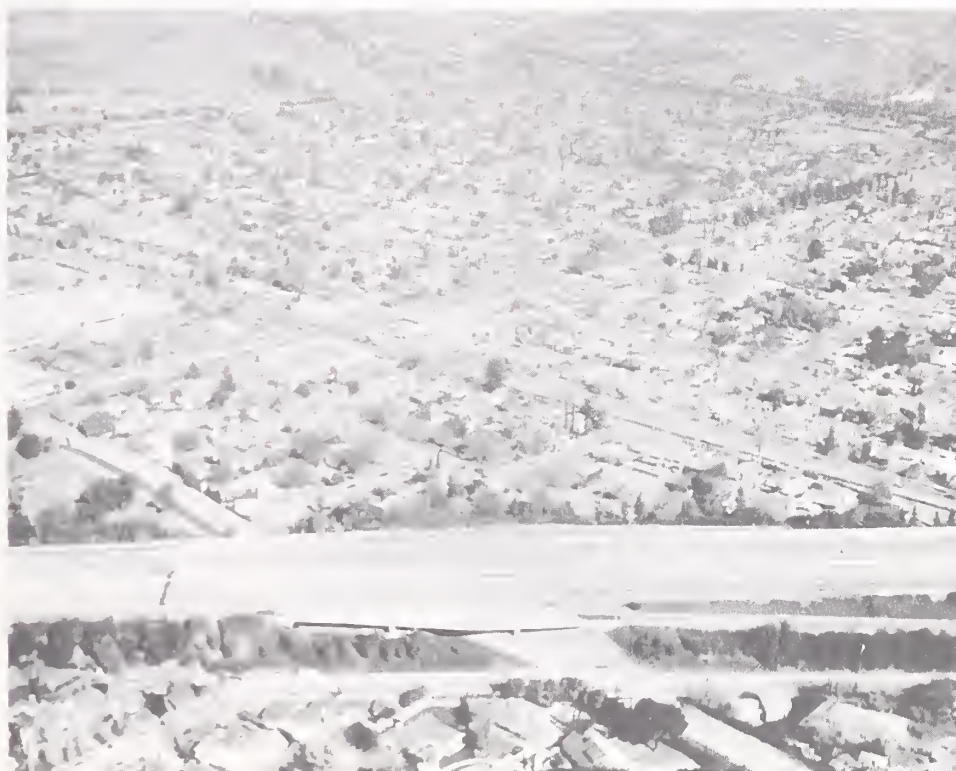
Figure 4.25 shows an aerial view, and 4.26 a ground-level view, of the SR118 bridge at Bull Creek Canyon Channel. The bridge did not collapse completely, but many of the piers were severely damaged, as shown in figures 4.27 and 4.28. In addition to pier damage, there was significant damage to the abutments, including cracked wing walls, settlement of soil behind the abutments, and possible shifting of the abutments. Plan and elevation views of the bridge are shown in figure 4.29, and pier details in figure 4.30.

Figure 4.25. Aerial view of State Route 118 at Bull Creek Canyon Channel, looking to the north (Photo courtesy of FHWA).

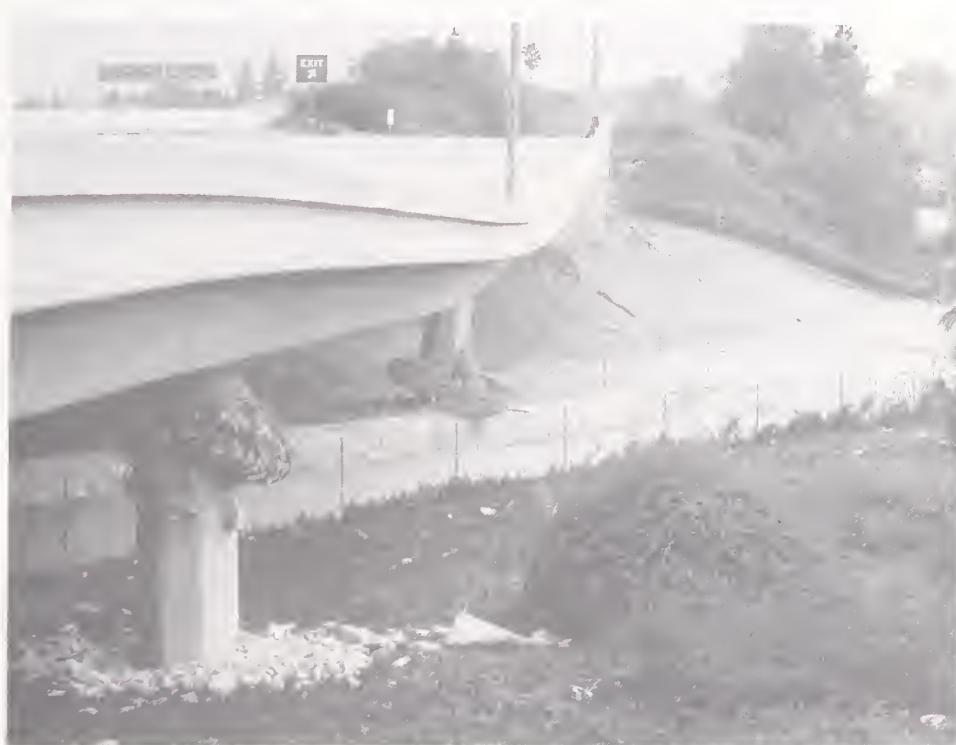
All ten of the piers in Bent 3 failed in combined shear and compression near their bases, as shown by figures 4.27 and 4.28. In Bent 2, Piers on the south side of the span failed near their top end, as shown in the left foreground of figure 4.26, and the damage became progressively less for piers to the north in Bent 2. The farthest north piers in Bent 2 showed relatively little damage - only diagonal shear cracks near the base, with no spalled concrete. This uneven distribution of damage to piers was probably caused by the asymmetric plan geometry of the bridge, as shown in figure 4.29.

Figure 4.26. Ground-level view of State Route 118 at Bull Creek Canyon Channel, looking along the south edge, towards the east.

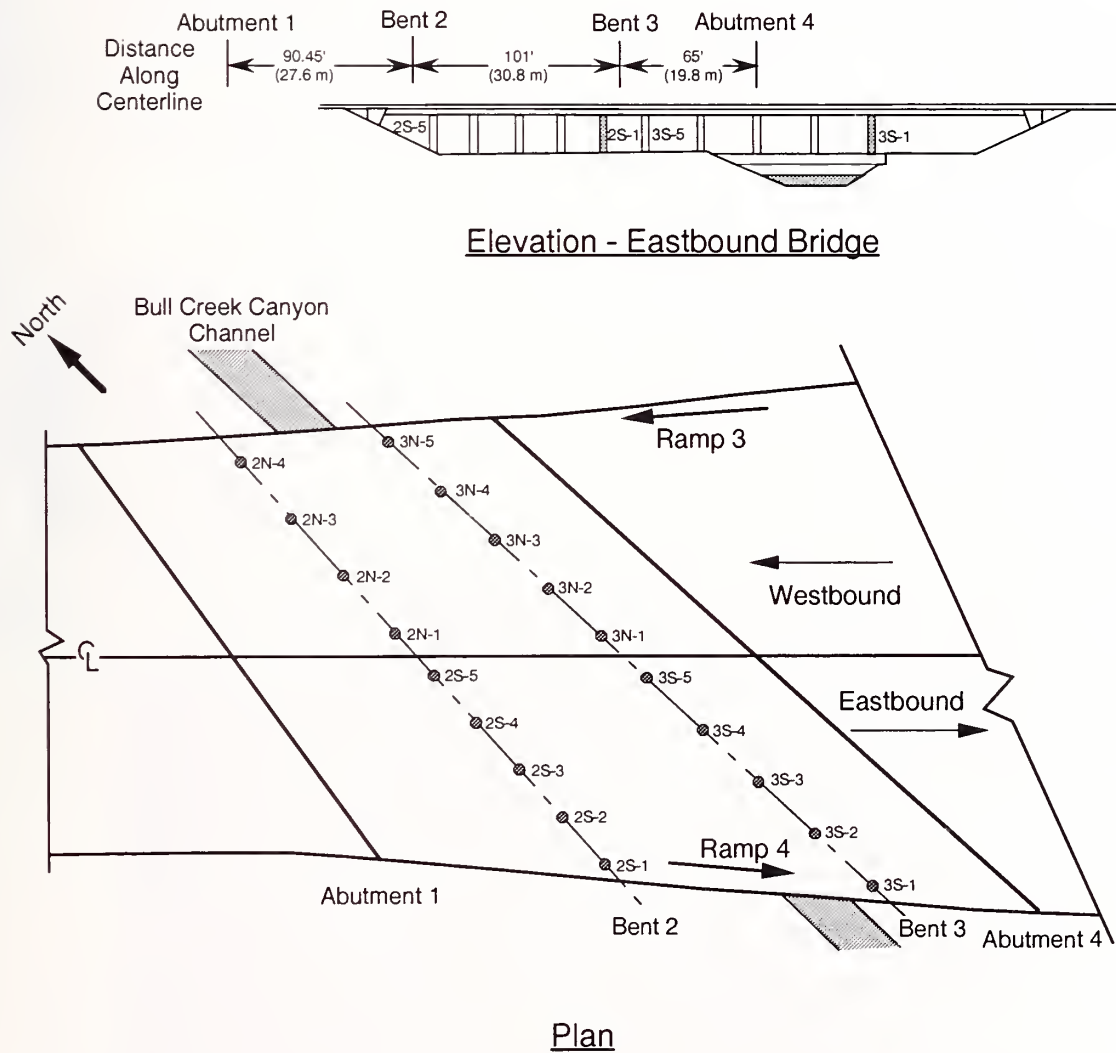
# SR 118 Bull Creek Canyon Channel Bridge

Figure 4.29. Plan and elevation views of State Route 118 at Bull Creek Canyon Channel.

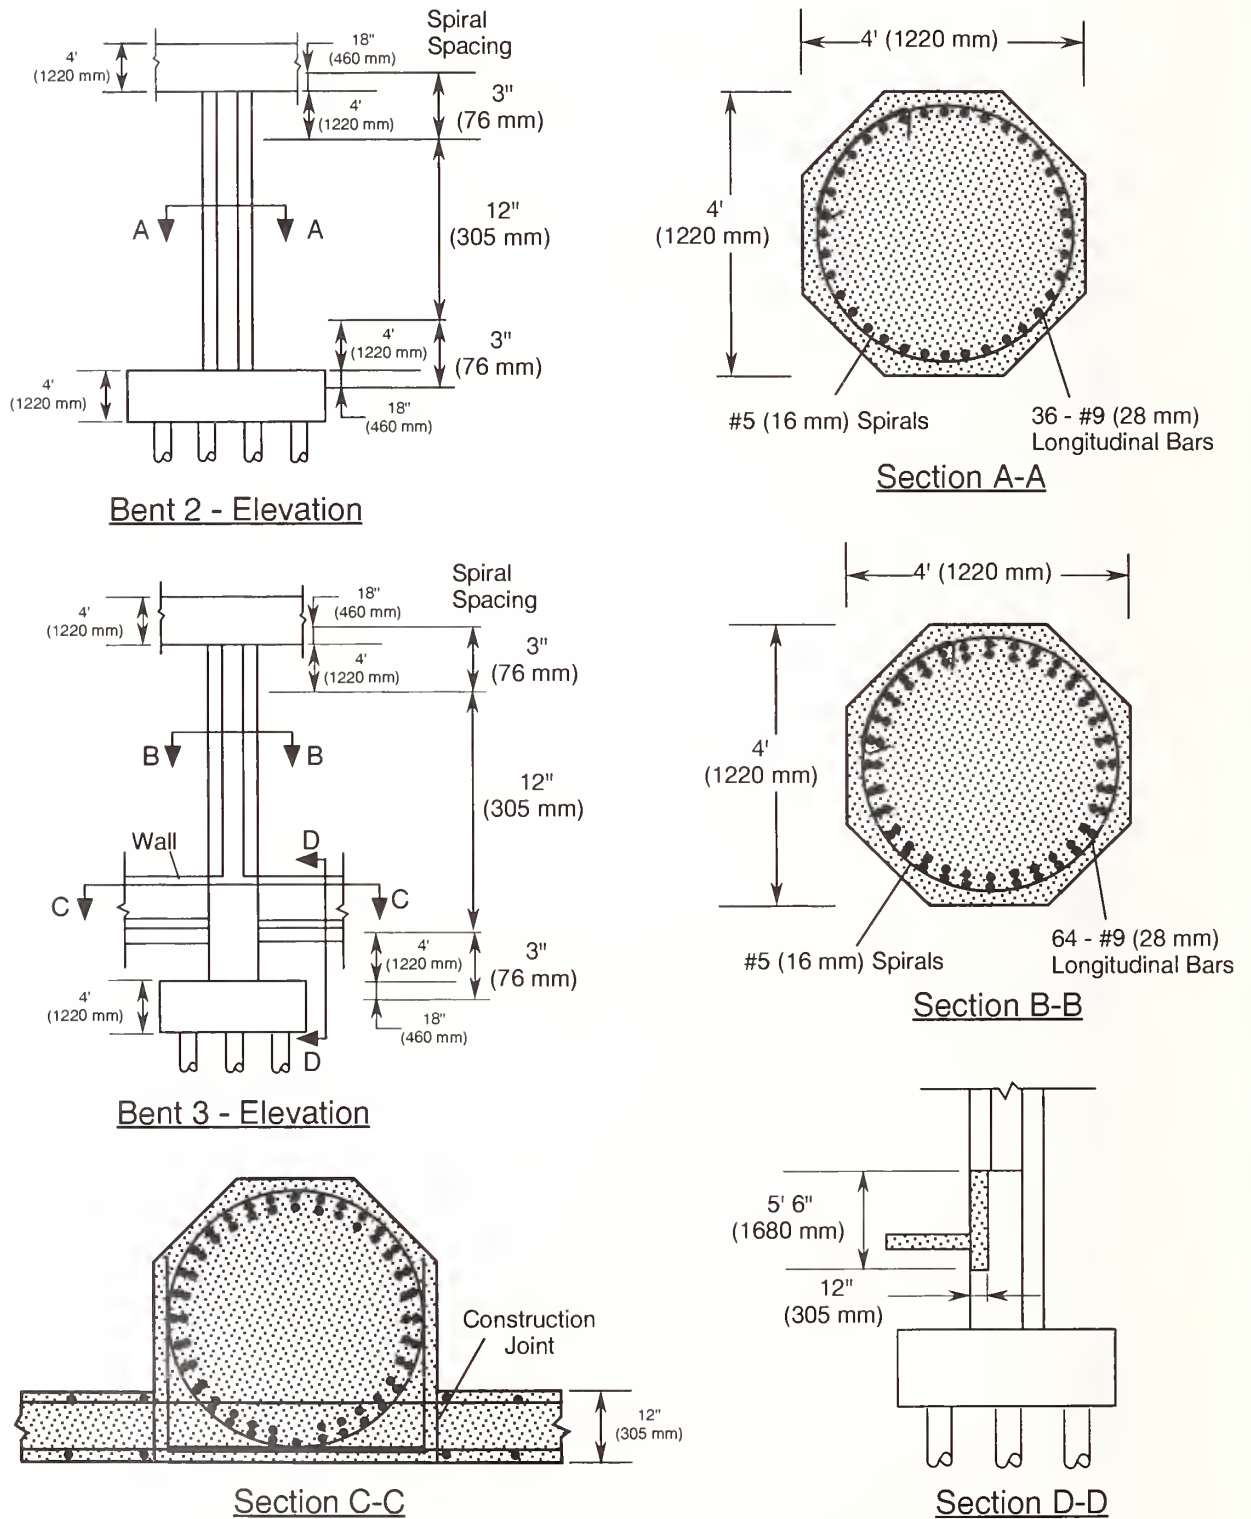
# SR 118 Bull Creek Canyon Channel Bridge Piers

The confining reinforcement in the piers, shown in figure 4.30, is inadequate by current standards. Spiral confining hoops were spaced at 76 mm (3 in) near the top and bottom of each pier (presumably to provide confinement in potential plastic hinge regions), but the spacing was 305 mm (12 in) over most of the pier height. All pier failures occurred in the zone of wide spiral spacing. Another factor contributing to pier failure was that the effective lengths of the piers were much shorter than the distance between the footings and the girder soffit. The lengths of piers varied between roughly 6000 and 9100 mm (20 and 30 ft). In Bent 2, the effective pier lengths were decreased roughly one-third by compacted backfill soil above the pier footings. In Bent 3, the pier lengths were also decreased roughly one-third, but by a reinforced concrete channel liner wall, which was cast abutting the piers (fig. 4.30, section C-C). The shortened effective pier length resulted in stiffer piers, which were more susceptible to shear-dominated failure than bending-dominated failure.

Figure 4.30. Pier details for State Route 118 at Bull Creek Canyon Channel.

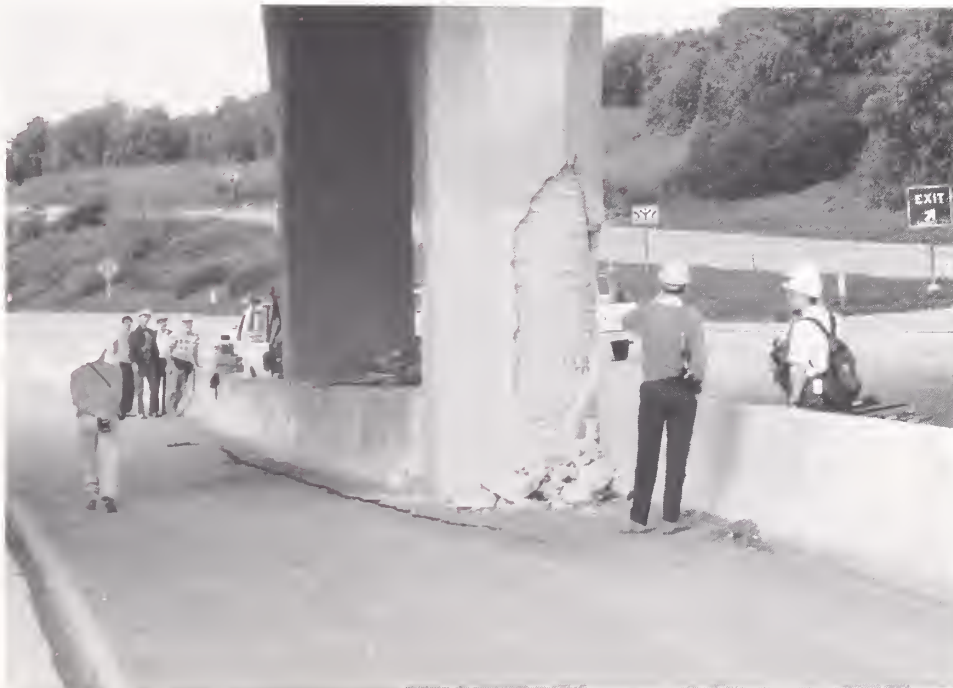
This bridge was designed in 1971, after the San Fernando earthquake. It was not damaged seriously in the Northridge earthquake. The bridge has a fairly simple configuration: a two-span prestressed concrete box girder superstructure (spans of 50.3 m and 52.4 m [165 and 172 ft]), continuous over a central two-pier bent, with the superstructure resting on seats at each abutment. The seat lengths were generous: approximately 1500 mm (5 ft). The bridge alignment is skewed about 21 degrees. The only significant damage suffered by the bridge was extensive spalling at one of the central piers, as shown in figure 4.31. The pier damage appeared to be limited to the cover concrete. This pier could be repaired relatively easily, and the bridge returned to full service. The spiral hoop reinforcement in the piers was #5 (16 mm) spirals spaced 89 mm (3.5 in), which is similar to the level of confining reinforcement required by current design codes. It is interesting to note that these piers have similar geometry and reinforcement content as the piers at the nearby Mission-Gothic Undercrossing, which were severely damaged. However, these piers are more flexible because they are taller and have a somewhat smaller diameter than the piers at the Mission-Gothic Undercrossing.

The good seismic performance of this bridge can probably be attributed to two factors. First, the central piers performed well because they contained adequate confining reinforcement and they were slender enough that they were not prone to a shear-dominated failure mode. Second, the overall geometry of the bridge is fairly compact, so that much of the lateral forces were carried by the abutments rather than the central piers. It is not common to see extensive seismic damage to short-span overpasses of this type.

Figure 4.31. SR118 Ruffner Ave. Overcrossing, easternmost central pier, looking to the west.

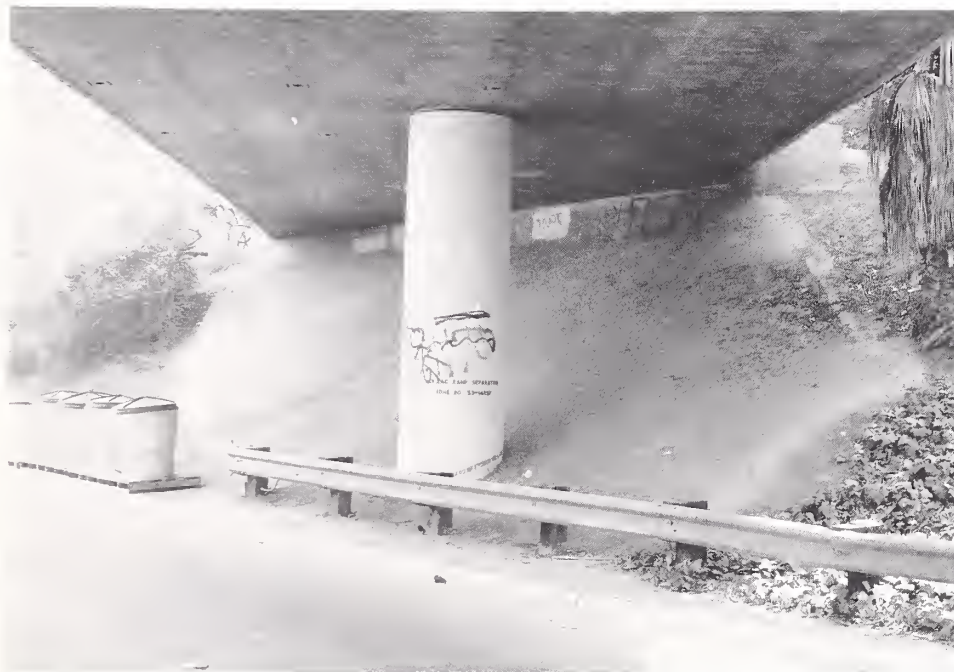
Figure 4.34. Cadillac Ave. ramp; view to east showing jacketed pier.

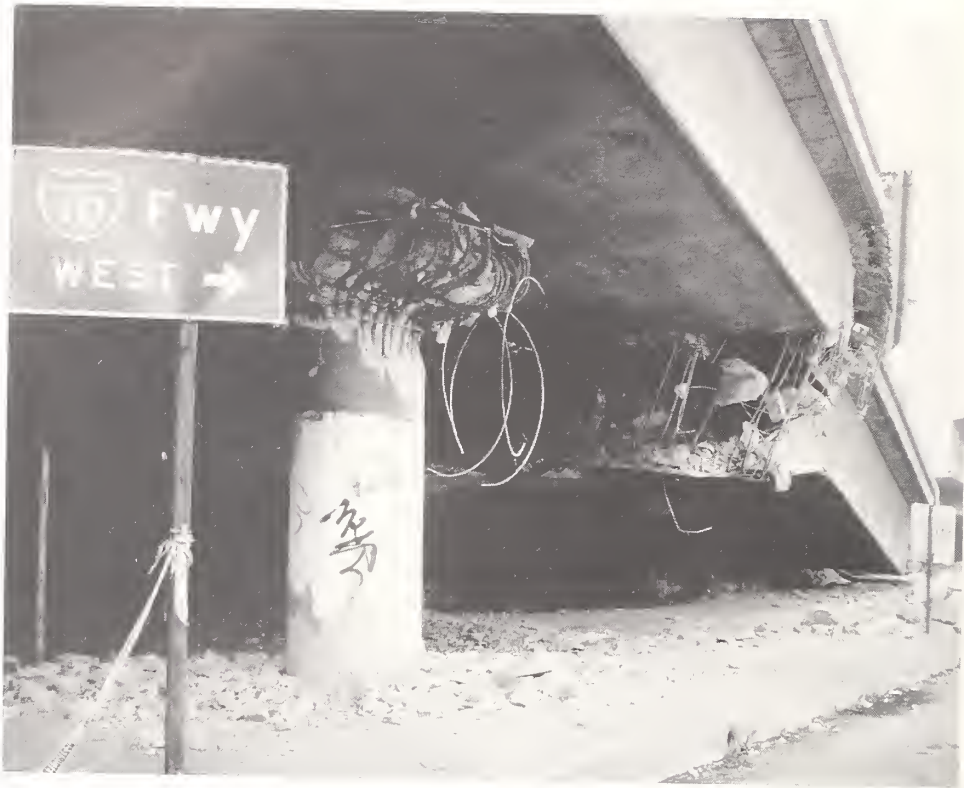
Figure 4.38 is a ground-level view of the portion of the westbound lane that collapsed to the ground at the hinge located between Bents 7 and 6. The pier in the foreground is the northernmost pier of Bent 7. It is seen that there was extensive column shortening due to the failure of the lateral reinforcement to provide adequate confinement of the core concrete. Fractured lateral reinforcement can be seen to the right of the failed portion of the pier. Figure 4.39 shows the other two piers of Bent 7 which supported the westbound lane. Extensive failure and column shortening is evident. The concrete block wall behind the piers is part of a storage building that was constructed beneath the bridge structure. The storage building extended from

Venice Blvd. to La Cienega Blvd. The piers of Bent 7 which supported the eastbound lane suffered relatively minor damage, and the roadway to the east of Bent 7 remained largely at its original elevation.

Figure 4.38. Collapsed westbound lane of I10 at Venice Blvd.; pier of Bent 7 in foreground.

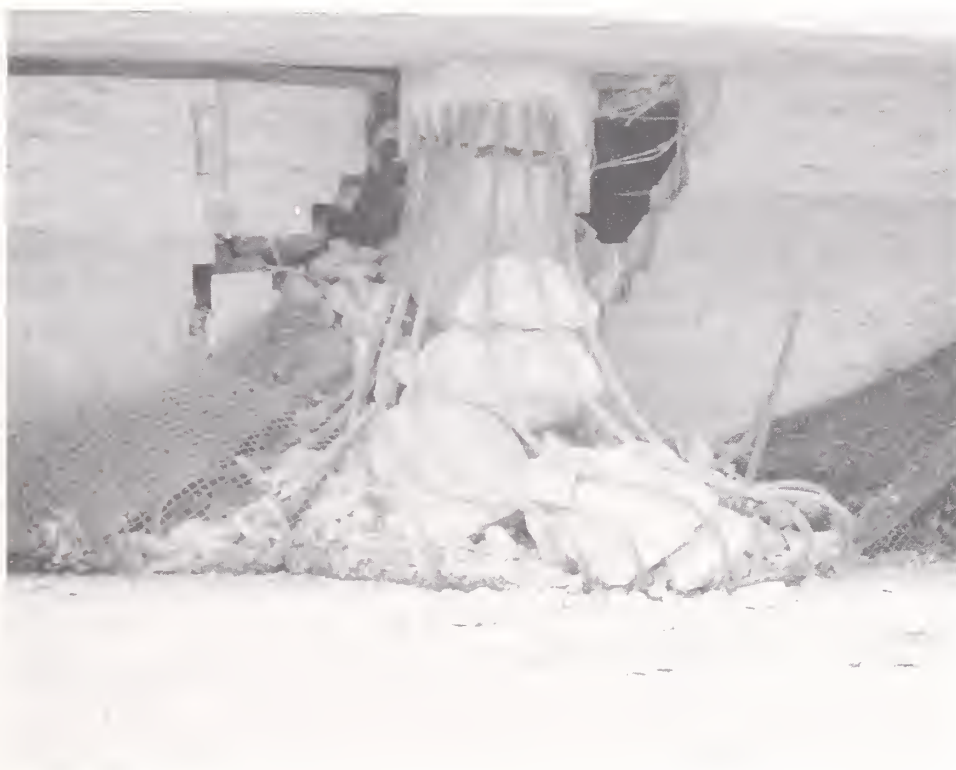
Figure 4.40 shows the northernmost pier of Bent 6, located just to the west of the hinge. This pier totally disintegrated, but the storage building prevented the roadway from collapsing to the ground. Figure 4.41 shows the southernmost pier supporting the eastbound lane at Bent 3. The top of the pier is severely damaged and it is likely that the storage building prevented the total collapse of the roadway.

Figure 4.40. Northernmost pier of Bent 6 supporting westbound lane of I10 (west of Venice Blvd.).
